**DEPARTMENT OF TRANSPORTATION**

Contract #: 04-0120F4Cty: SF/ALA Rte: 80 PM: 13.2/13.9File #: 1.28**WELDING INSPECTION REPORT****Resident Engineer:** Casey, William**Address:** 333 Burma Road**City:** Oakland, CA 94607**Report No:** WIR-027846**Date Inspected:** 25-Jun-2012**Project Name:** SAS Superstructure**OSM Arrival Time:** 700**Prime Contractor:** American Bridge/Fluor Enterprises, a JV**OSM Departure Time:** 1930**Contractor:** American Bridge/Fluor Enterprises, a JV**Location:** Job Site**CWI Name:** Andrew Keach**CWI Present:** Yes No**Inspected CWI report:** Yes No N/A**Rod Oven in Use:** Yes No N/A**Electrode to specification:** Yes No N/A**Weld Procedures Followed:** Yes No N/A**Qualified Welders:** Yes No N/A**Verified Joint Fit-up:** Yes No N/A**Approved Drawings:** Yes No N/A**Approved WPS:** Yes No N/A**Delayed / Cancelled:** Yes No N/A**Bridge No:** 34-0006**Component:** SAS Tower**Summary of Items Observed:**

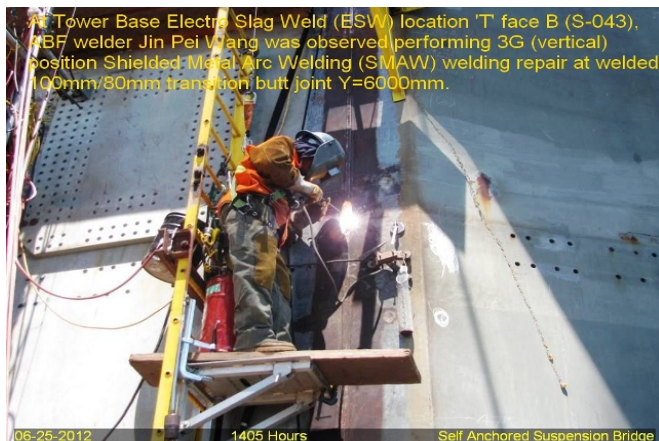
At Tower Base Electro Slag Weld (ESW) this QA observed ABF welder Jin Pei Wang continuing to perform repair excavation at location 'T' face B due to Ultrasonic Testing (UT) detected defect. The repair excavation is being undertaken per Caltrans approved Request for Weld Repair (RWR)#201206-055. The welder was noted using carbon air arc gouging followed by grinding using a die grinder. During the excavation, the indication at depth 38mm was one indication measuring 27mm long and this was confirmed using Magnetic Particle Testing (MT). The welder continued the excavation at depth 42mm and at this depth there was no more linear indication visible. The welder was told by ABF QC to grind and clean the whole area especially the deep gouges. When the grinding was completed, the final depth of the excavation was measured 50mm. ABF QC Jesse Cayabyab performed the final MT on the boat shape excavation and found no significant defect during the test. This QA performed the MT verification and noted same result. The final dimension of the excavation located at Y=6000mm was 260mm long X 55mm wide X 50mm deep.

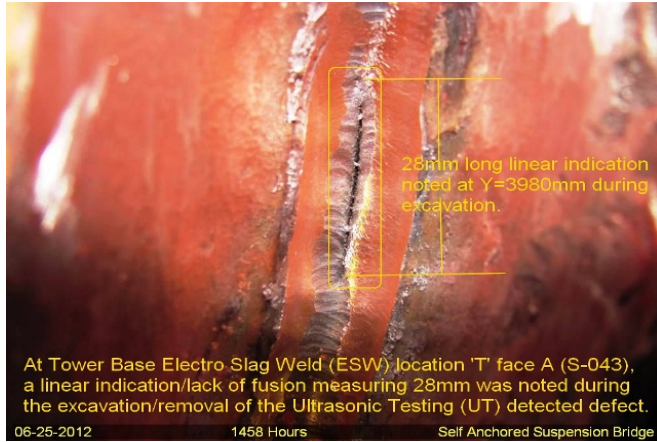
At Tower Base Electro Slag Weld (ESW), this QA observed ABF welder Lou Xiao Hua perform repair excavation at location 'T' face A (S-043) due to Ultrasonic Testing (UT) detected defect. The repair excavation is being undertaken per Caltrans approved Request for Weld Repair (RWR)#201206-057. The welder was noted using carbon air arc gouging followed by grinding using a die grinder. During the excavation, one linear indication located at Y=3980mm was noted at depth 36mm and was measured 27mm long. This was confirmed using Magnetic Particle Testing (MT). The welder continued the excavation at depth 40mm and the indication was measured 25mm long. The welder continued the excavation at depth 45mm and the indication was measured 20mm long and at this time the welder has stopped the excavation due to end of the shift. The welder has told ABF QC Andrew Keach and this QA that he will continue the excavation tomorrow.

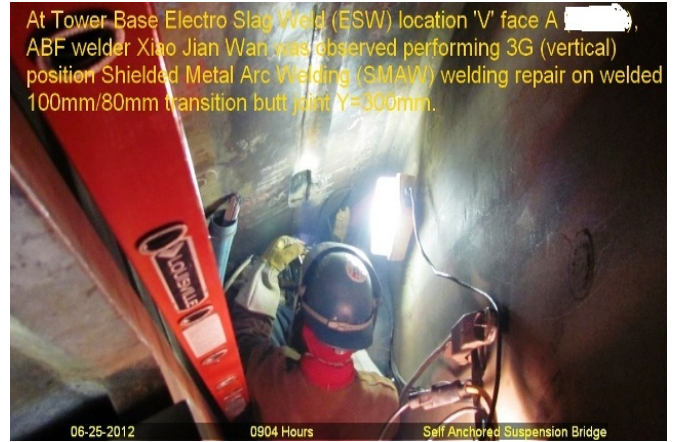
At Tower Base Electro Slag Welding (ESW) 100mm/80mm transition weld butt joint 'V' face A (W-043), QA randomly observed ABF/JV qualified welder Xiao Jian Wan continuing to perform CJP groove welding repair at Y=300mm to Y=580mm with excavation dimensions of 280mm long X 70mm wide x 55 mm deep per Caltrans approved Request for Welding Repair (RWR) #201206-42. The welder was observed welding in the 3G (vertical) position utilizing Shielded Metal Arc Welding (SMAW) with 3.2mm diameter E7018H4R electrode implementing welding procedure ABF-WPS-D15-1000-Repair Rev. 2. The repair excavation was preheated to more than 300 degree Fahrenheit using Miller Proheat 35 Induction Heating System. During the shift, ABF QC Andrew Keach was noted monitoring the welder with measured working current of 123 amperes during welding. At the end of the shift, the welding repair of weld joint mentioned above was completed.
